**NOTICE OF MEETING  
LANDMARK COMMISSION  
OF THE CITY OF GALVESTON  
MONDAY, JULY 21, 2025 - 4:00 PM  
CITY COUNCIL CHAMBERS, 2ND FLOOR OF CITY HALL  
823 ROSENBERG, GALVESTON, TEXAS  
REGULAR MEETING**

## 25LC-029

Request for a Certificate of Appropriateness for modifications to the structure including removing a covered balcony .

## PROPERTY INSPECTION REPORT FORM

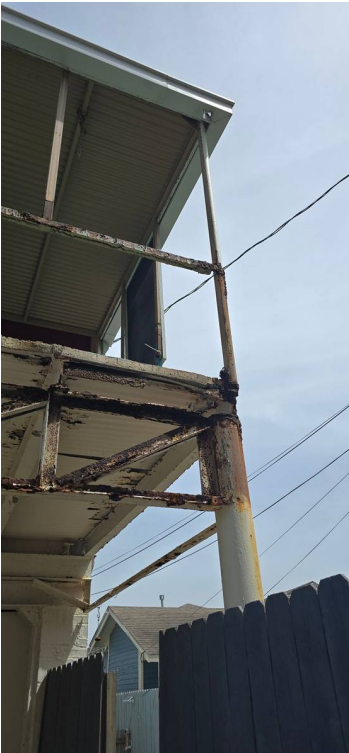
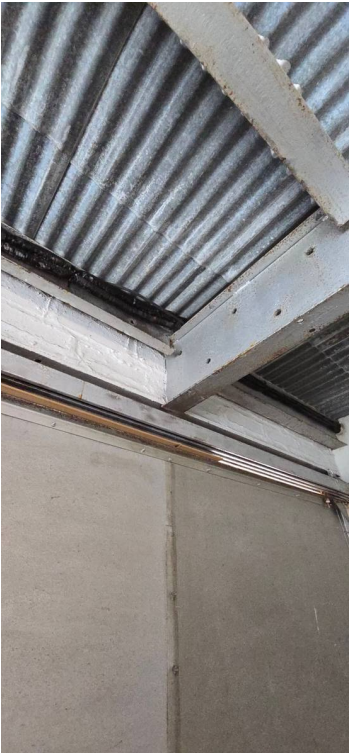
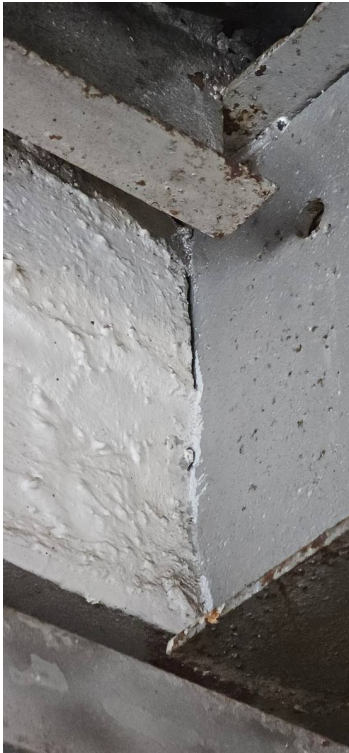
Severe corrosion on right side beam present at time of inspection. Recommend

member is replaced.

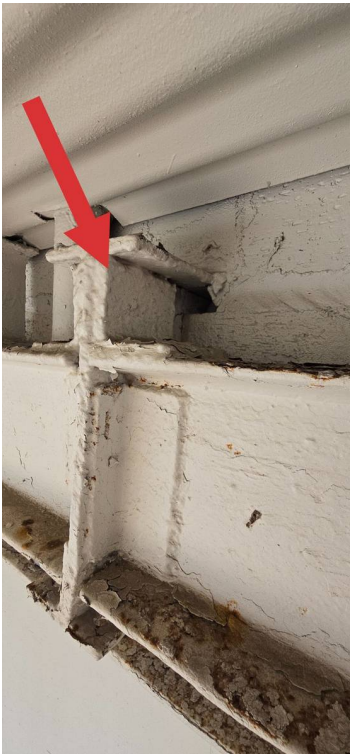
**Beam passes through CMU block wall and is an attachment point for the steel I-beam ledger. Corrosion present. Recommend paint is removed and beam treated for corrosion.**

**Orange- Steel I-beam rests on CMU block wall. Behind cow hide there is evidence of step cracking in the block wall and it has been repaired. Home was built in 1949 and some movement is expected.**
